NASA Contractor Report 195376

Weldability of a Nickel-Based Superalloy

August 1994

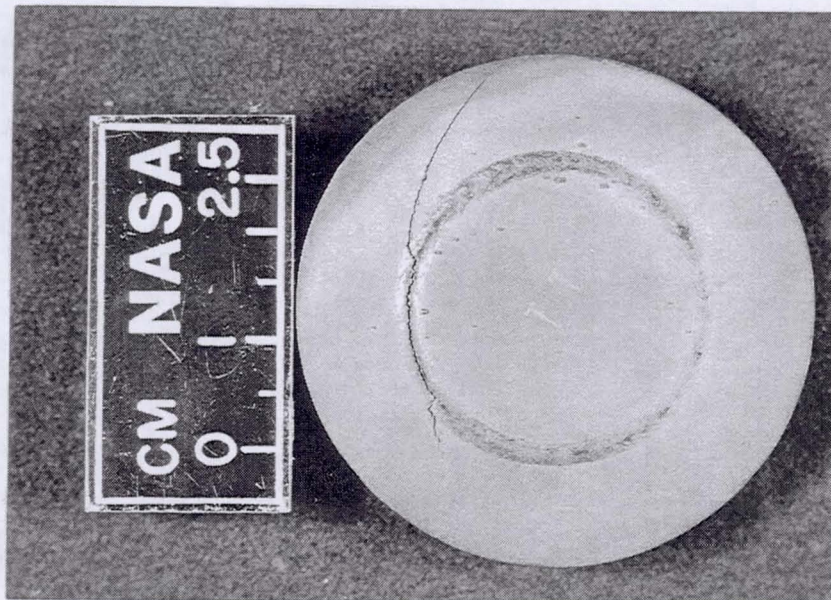
No cracking was found on the surface of any of the eleven 4.7 cm diameter specimens after welding. After the first step of the CR heat treatment, however, nine of the eleven specimens were severely cracked. Fig. 3 is typical of the cracked specimens, with a crack running down the centerline of the weld and extending into the base metal.

Fig. 3. Strain-age Cracking in 4.7 cm Diameter Specimen.

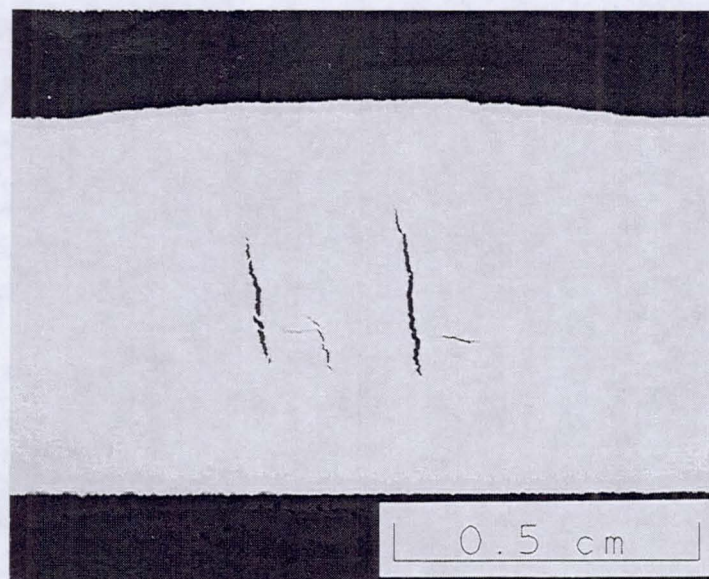
The two specimens that did not exhibit surface cracking had received the pre-weld anneal. These two specimens appeared to survive all four steps of the CR heat treatment; no cracks were found on the surface when examined by optical microscopy. However, transverse sections revealed cracking in one of the specimens. The cracking ran through about 40% of the thickness of the specimen, but was not open to either surface (Fig. 4). Furthermore, both of the tangential sections revealed similar sub-surface cracking (Fig. 5).

Fig. 4. Sub-surface Cracking in a Transverse Weld Section -
4.7 cm Diameter Specimen

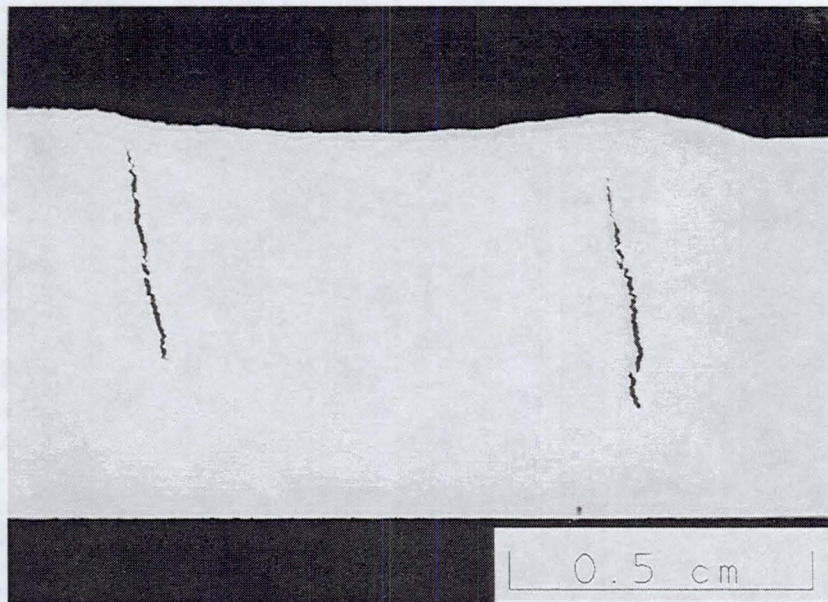
This sub-surface cracking is by nature hazardous because it was not revealed by visual inspection techniques and was not always found in transverse weld sections. Tangential weld sectioning was the only reliable method of finding these cracks in circular welds.

Fig. 5. Sub-surface Cracking in a Tangential Weld Section - 4.7 cm Diameter Specimen

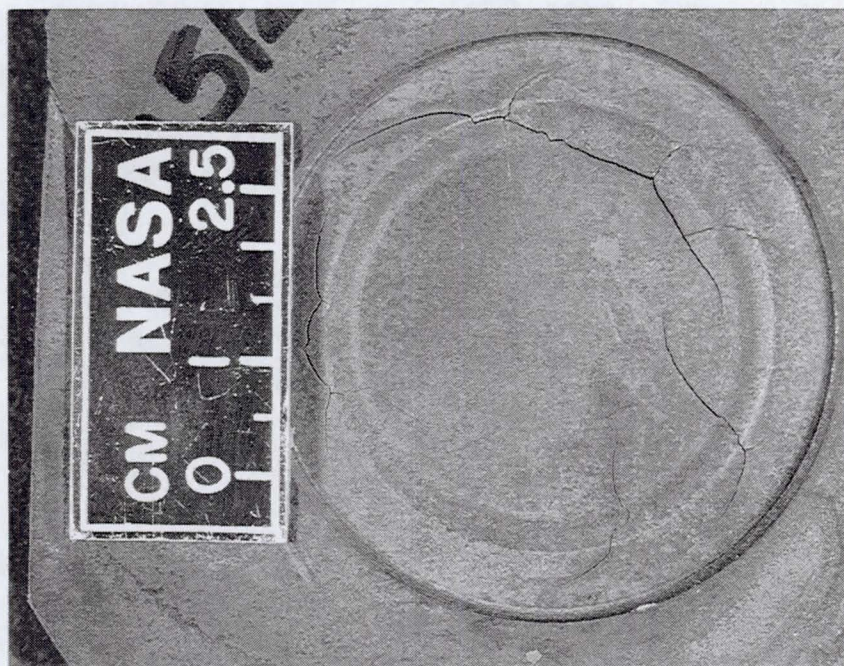
After welding, the two 10.2 cm diameter specimens which had the lowest heat input showed no signs of cracking by optical or dye-penetrant inspection. After the first step of the CR heat treatment, the specimens were again examined optically and no cracking was found. It was initially believed that if the specimens survived the first step of the CR heat treatment, then residual stresses would be relieved and strain-age cracking would no longer be a concern. They were therefore examined only after the last three steps of the CR heat treatment were complete. Severe cracking was evident at this time in both specimens (Fig. 6).

Fig. 6. Strain-age Cracking in a Welded and Aged 10.2 cm Diameter Specimen

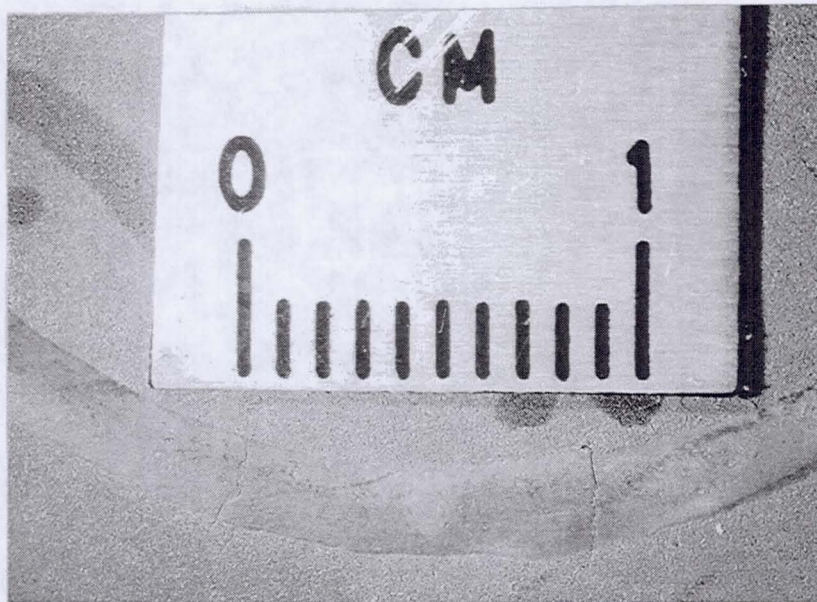
Examination of the third 10.2 cm diameter specimen, which had the highest heat input, revealed small transverse cracks on the face of the weld after the first step of the CR heat treatment (Fig. 7).

Fig. 7. Strain-age Cracking in a Welded and Solution Treated 10.2 cm Diameter Specimen.

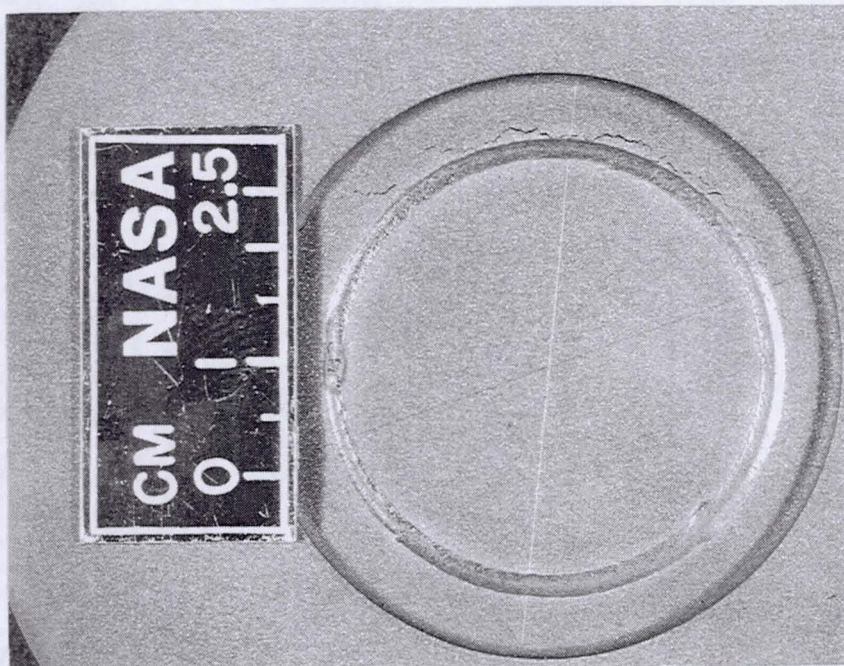
Immediately after welding, cracking was observed in the weld and HAZ of the fourth 10.2 cm diameter specimen, which had received the four-step CR heat treatment prior to welding (Fig. 8). This specimen represented a repair weld that might be necessary during or after the fabrication process.

A single attempt to simulate a repair by welding a fully aged specimen was unsuccessful due to cracking during welding. This is a problem since it is likely that some sort of repair would be necessary during or after the fabrication process.

Fig. 8. Cracking in a Simulated Repair Weld - 10.2 cm Diameter Specimen

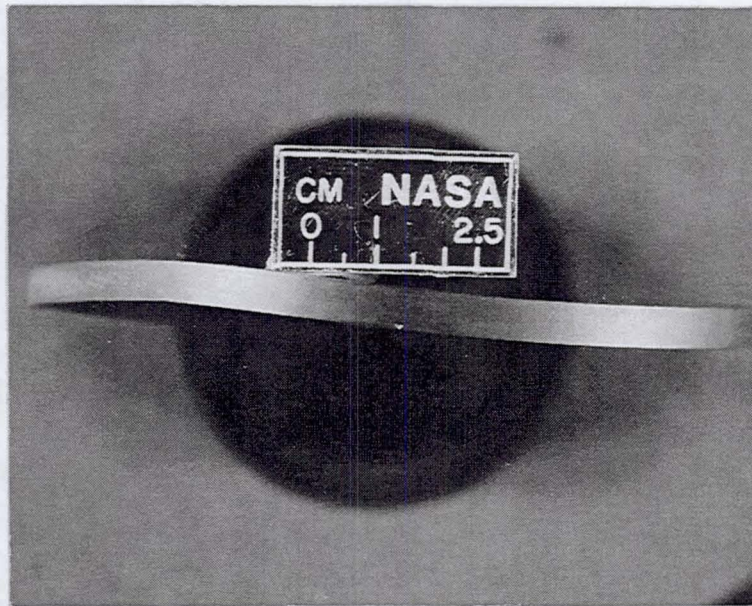
Metallographic examination of the 16.5 cm diameter specimens showed that no cracking was present after the weld/heat treatment process was completed. During the four-step CR heat treatment, however,

these specimens warped to the shape of a saddle (Fig. 9). No warpage occurred in the 4.7, 5.8, and 10.2 cm diameter specimens. The lack of cracking in the larger specimens indicates that the warpage may relieve the stresses that would cause cracking in more highly restrained weldments.

Fig. 9. Severe Warping in 16.5 cm Diameter Specimen.

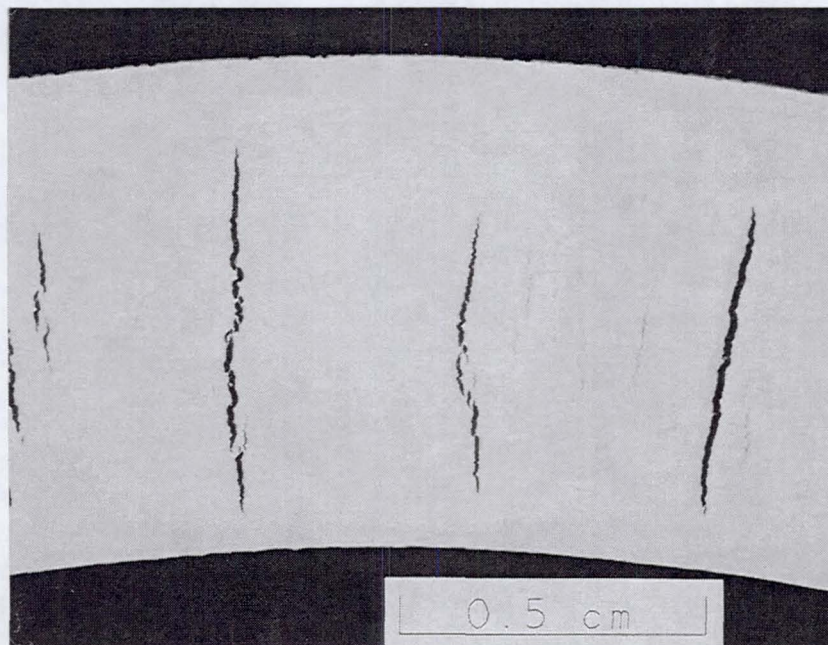
Longitudinal weld sectioning of these pieces was then performed, revealing severe sub-surface cracking (Fig. 10). These cracks resembled those found in the 4.7 and 5.8 cm diameter specimens and is especially alarming because it was not revealed by any of the NDE methods that were attempted.

Fig. 10. Sub-surface Cracking in Contractor-welded Pipe -
Sectioned Longitudinally Along the Weld Centerline
